Client a	IRIS Inspection Report	Page 1 of 10
Unit 123	Final Report	K-0xx-15 (Jxx22)

IRIS TUBE INSPECTION REPORT

Object Identification : Heat Exchanger Unit 123

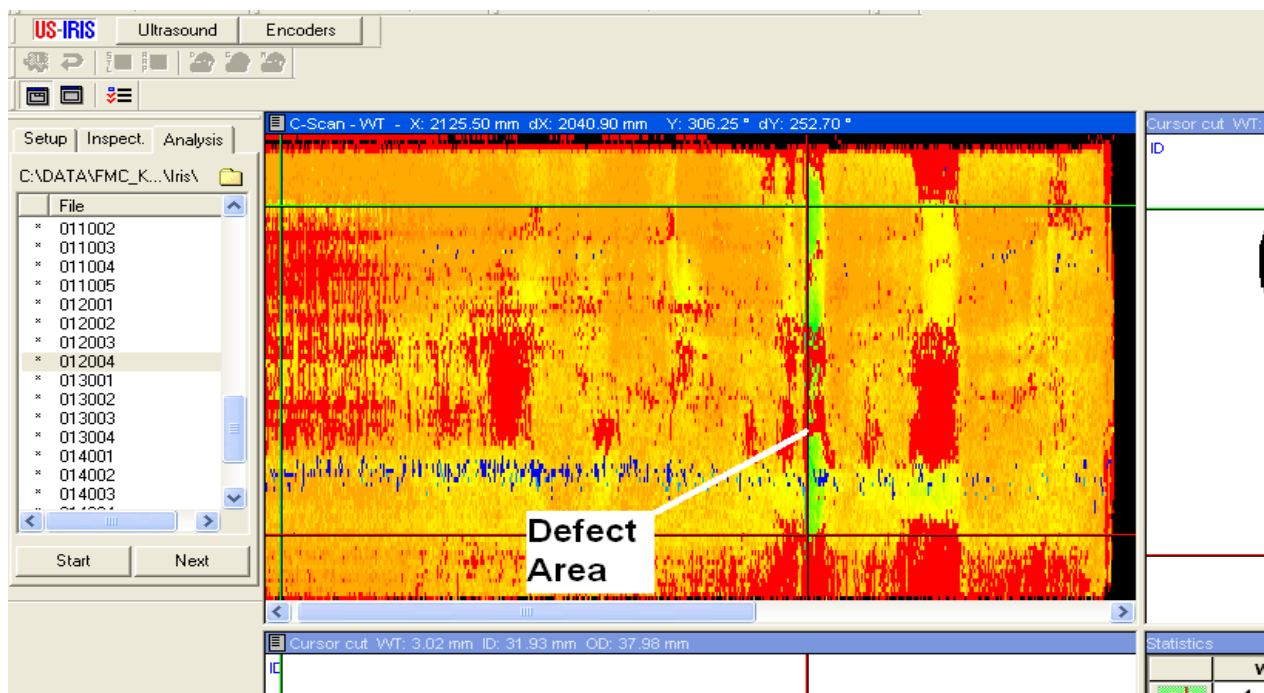
Figure 1

Below is one of the actual 'C-Scan' images taken from an inspected tube within Unit 123, this clearly showing a reduction to the external tube wall at the support plate positions.

Actual IRIS Scan taken from Unit 123 depicting wall loss at the support plate

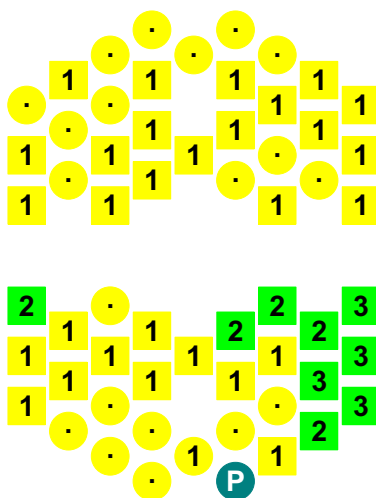
APPENDIX 01

The IRIS Inspection carried out on unit 123, identified external tube wall damage noted near to the support plates (wall loss percentages are identified per tube within the appendices).

General external tube wall damage was noted at the support plates, being in a selection of the tubes examined. This is depicted within appendix 1 which shows an overall defect picture, taken at the tube-sheet identifying (per legend) the maximum wall losses per tube.
