گزارش بازرسی تیوب های کولرهای هوایی به روش

میدان دور جریان گردابی (RFT)

E-2109 / Section 2 / Cell 6 بازرسی تیوب های کولر هوایی

شرکت بازرسی فنی و کنترل خوردگی تکین کو

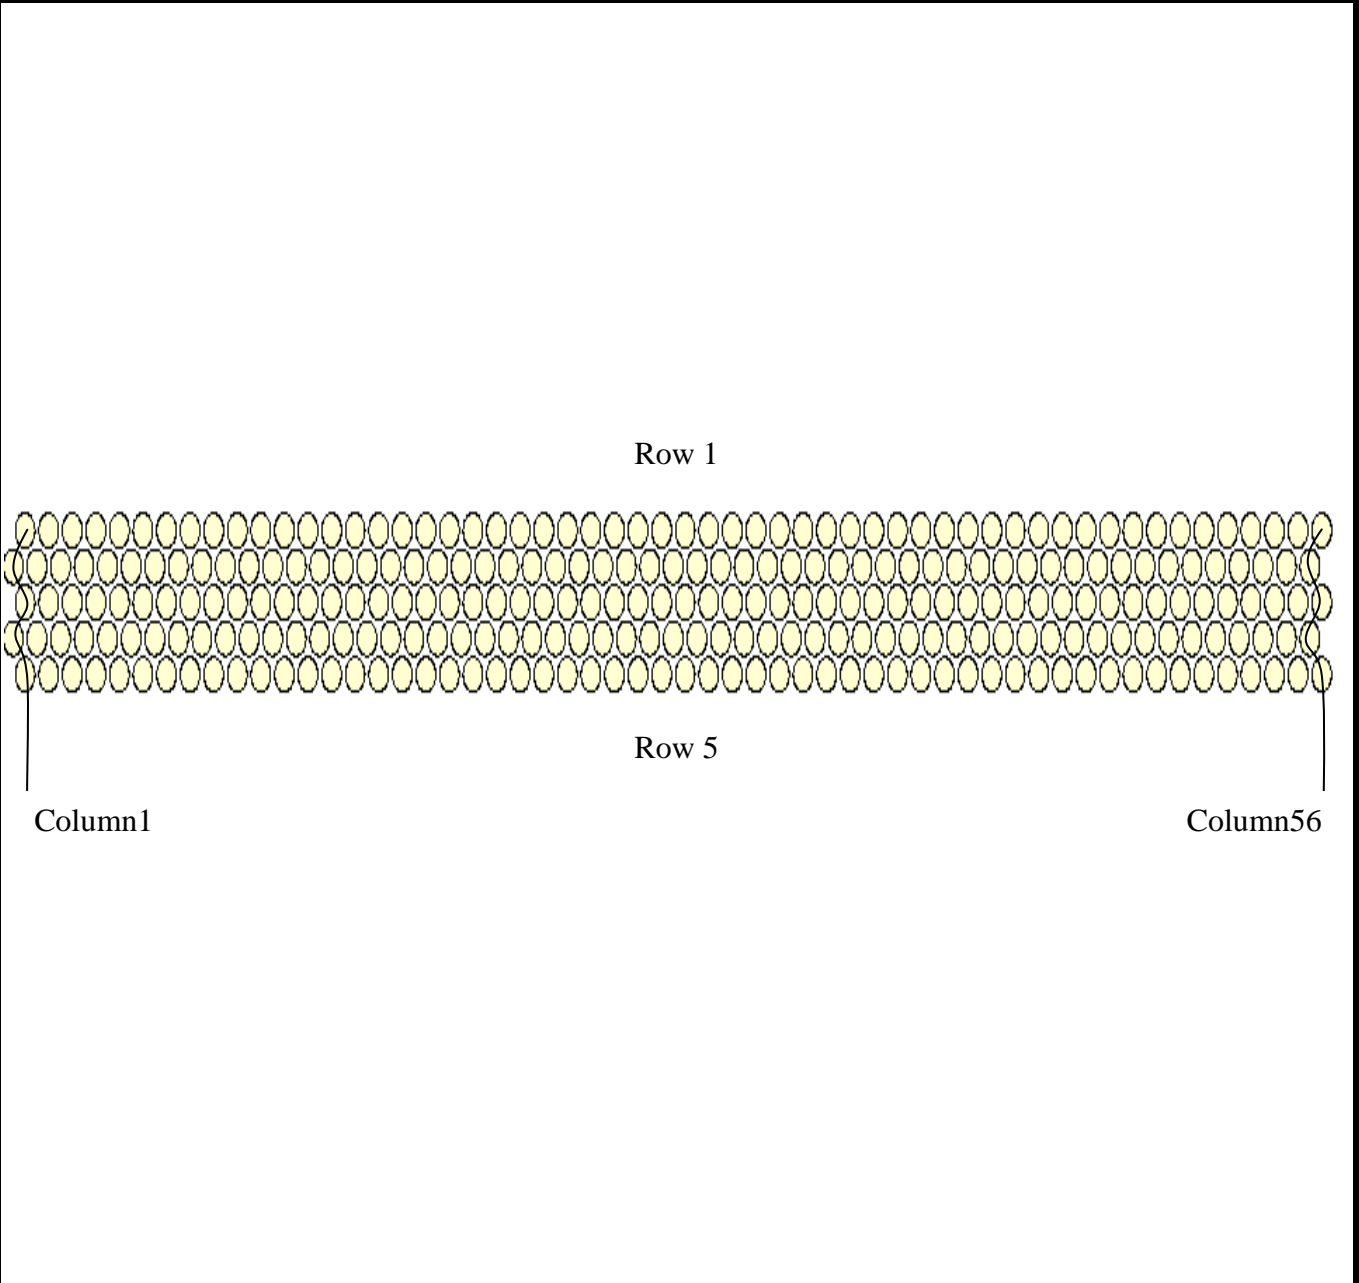
Tube Sheet Map

View: From North to south	Row 1: Top	Column 1: East
----------------------------------	-------------------	-----------------------

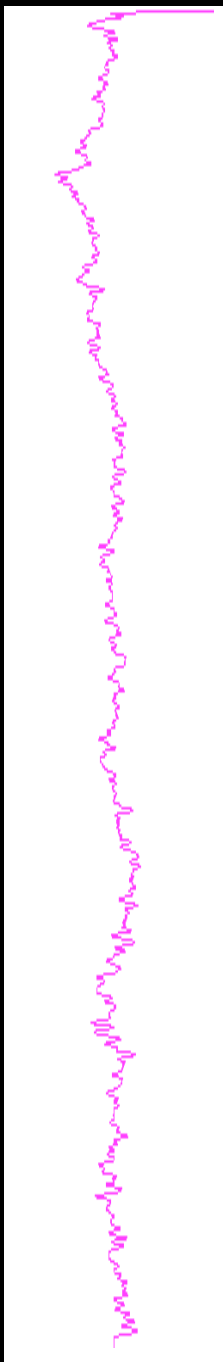
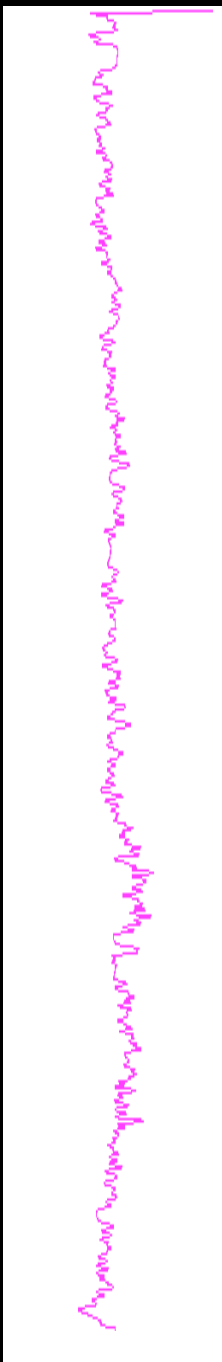
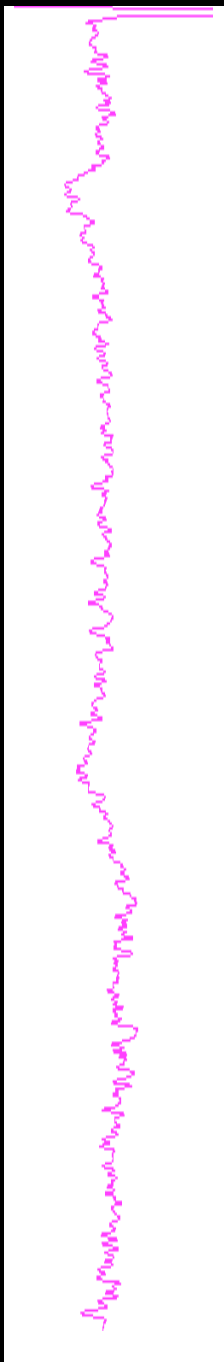
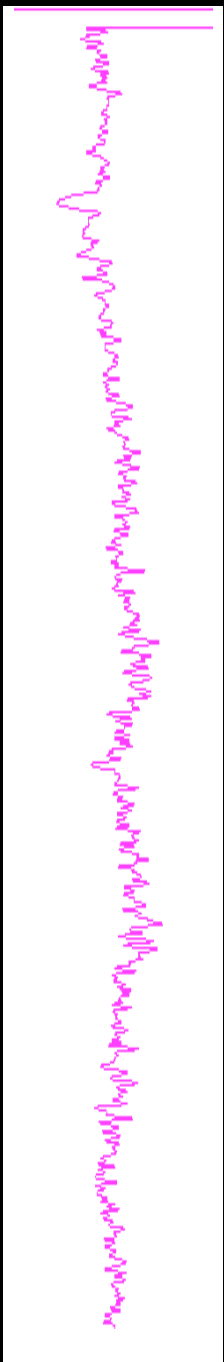
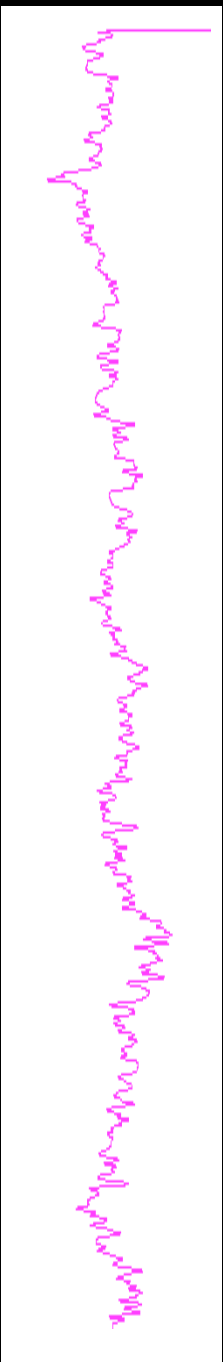
Row-Column	1-16	1-17	1-18	1-19	1-20	
Start : North

1
						2
3						
Unit: Meter						4
						5
						6
						7
						8
						9
End: South						10
	11					
	12.2

بخش هشتم Tube Defect Report می باشد که در این گزارش موقعیت نسبی خوردگی متناسب با طول لوله نمایش داده میشود. این گزارش برای لوله هایی که دارای خوردگی (کلاس یک تا چهار) هستند موقعیت سیگنال خوردگی را بر روی گزارش استریپ چارت با خطوط آبی رنگ مشخص می نماید. همچنین سیگنال مربوطه به رنگ صورتی نیز نمایش داده می شوند.

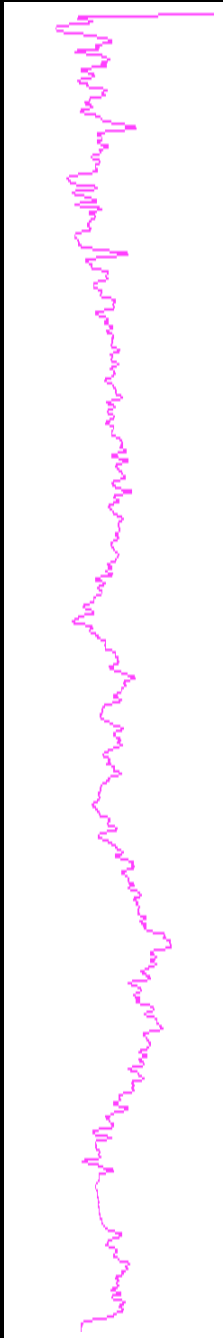
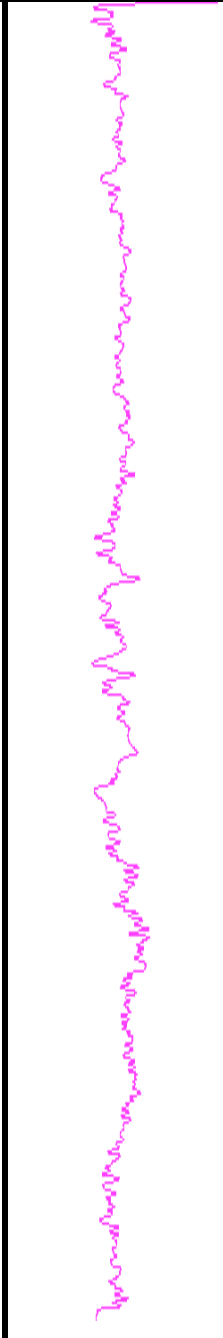
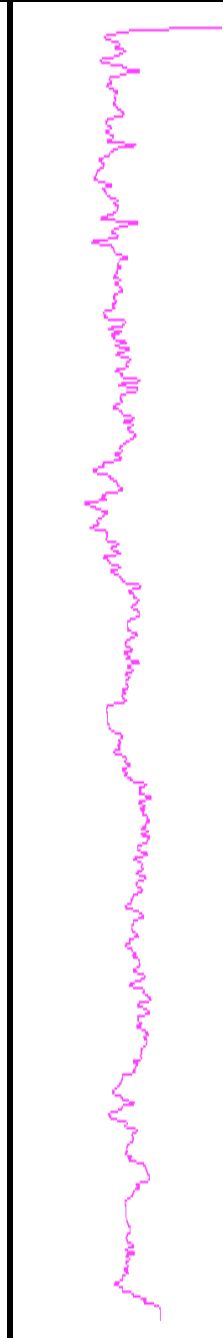
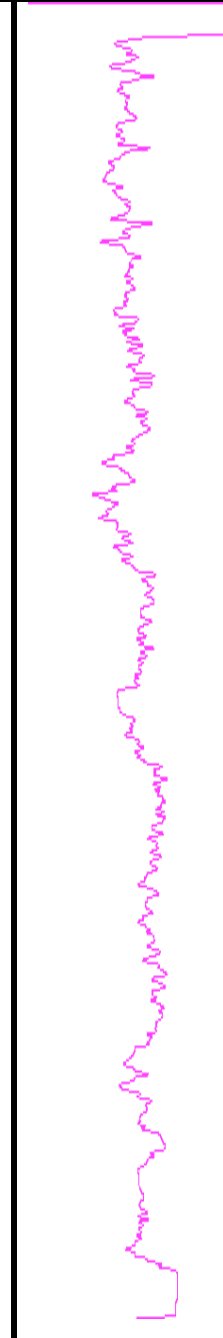
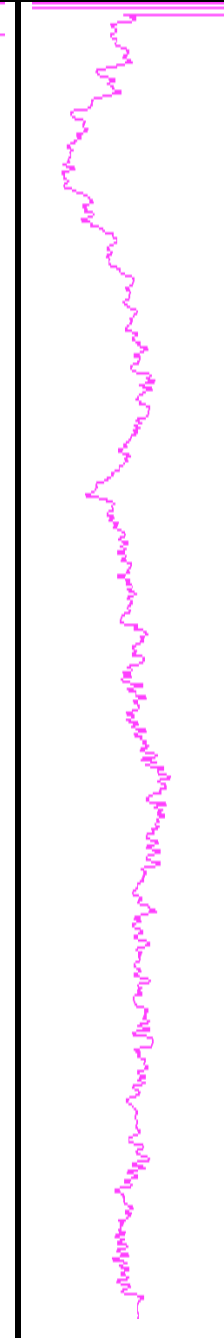
Tube Defect Report

Row-Column	1-21	1-22	1-23	1-24	1-25	
Start : North

1
						2
3						
Unit: Meter						4
						5
						6
						7
						8
End: South						9
						10
	11					
	12.2

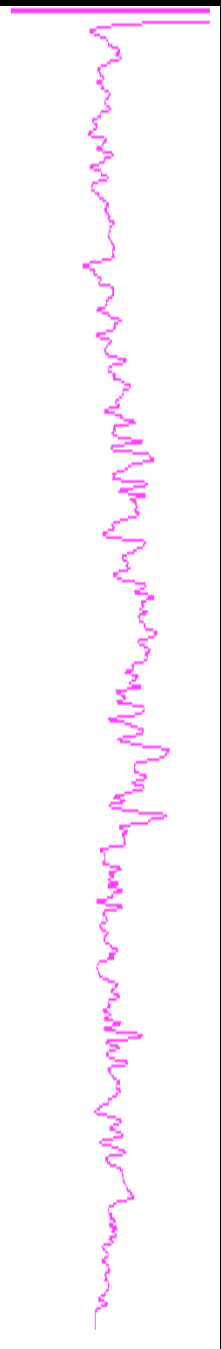
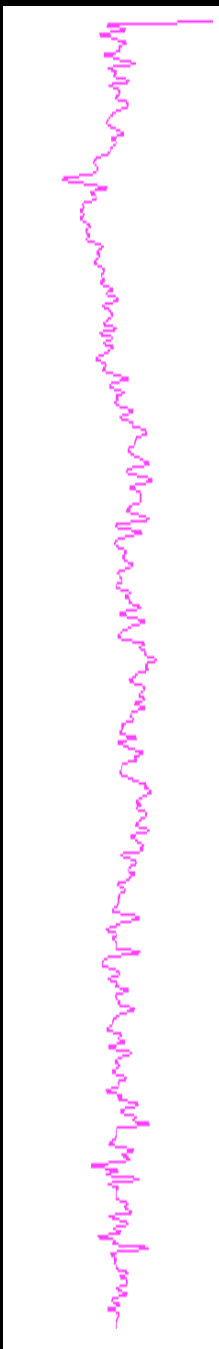
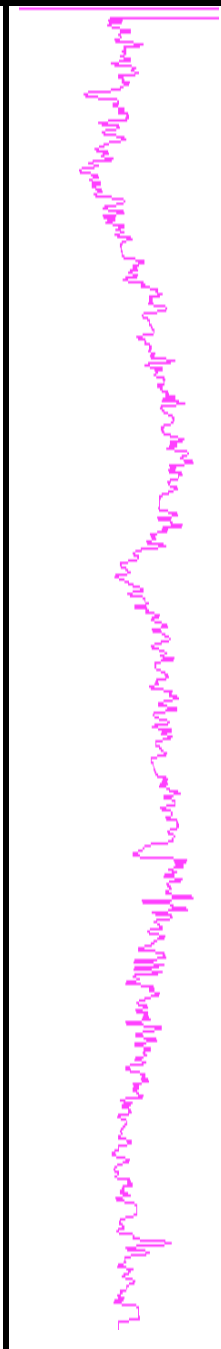
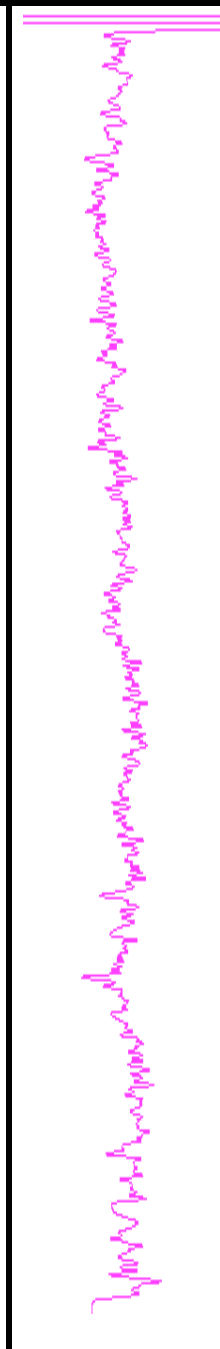
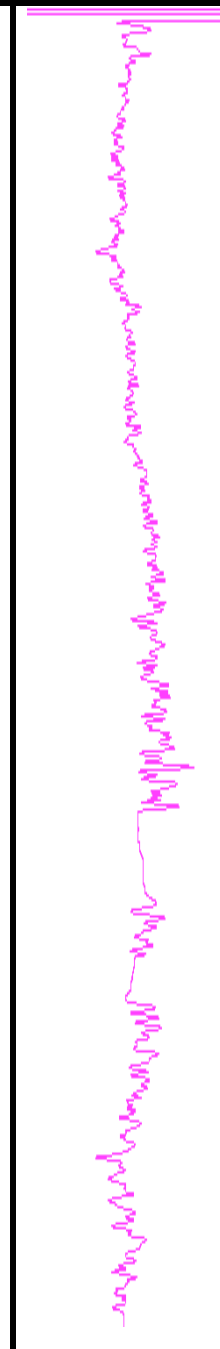
Tube Defect Report

Row-Column	1-31	1-32	1-33	1-34	1-35	
Start : North

1
						2
3						
Unit: Meter						4
						5
						6
						7
						8
End: South						9
						10
	11					
	12.2

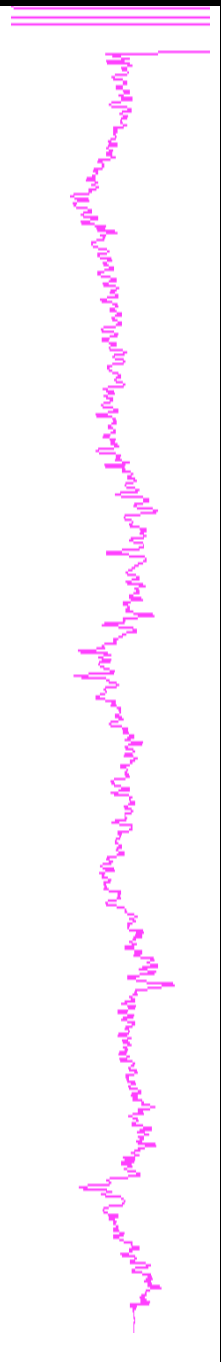
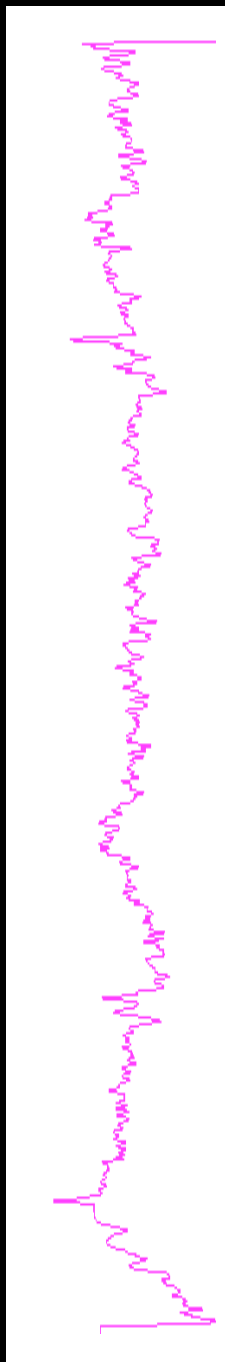
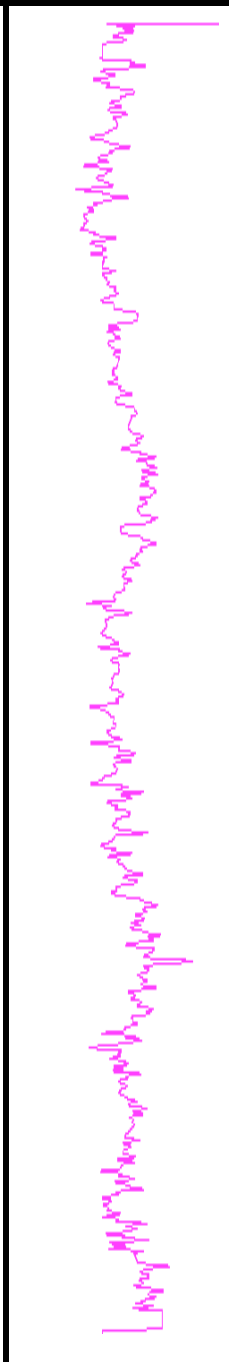
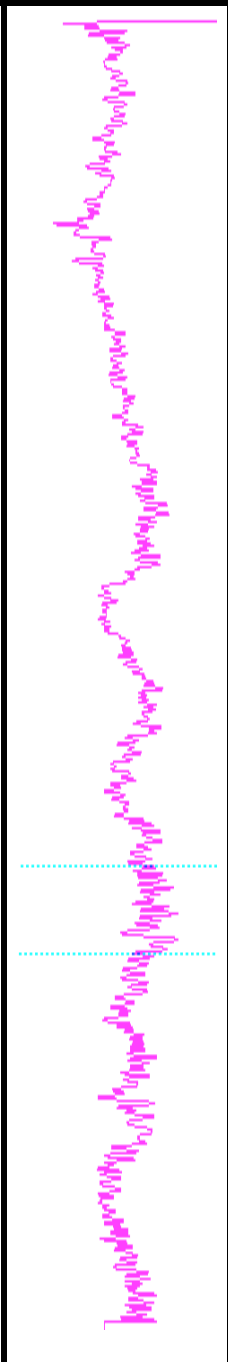
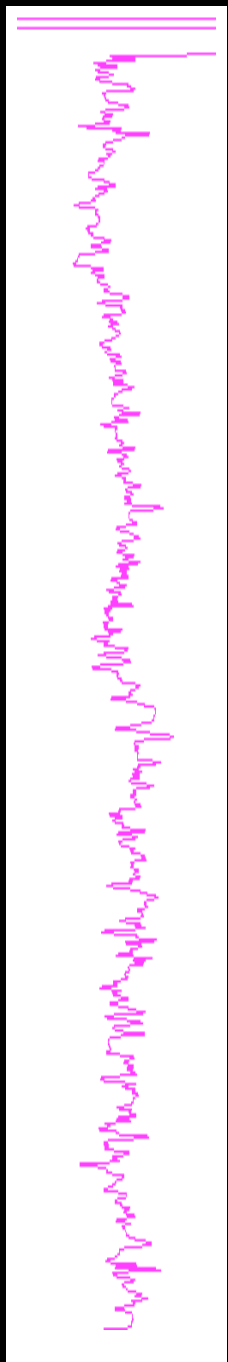
Tube Defect Report

Row-Column		1-51	1-52	1-53	1-54	1-55
Start : North	1

2					
	3					
Unit: Meter	4					
	5					
	6					
	7					
	8					
	9					
End: South	10					
	11					
	12.2

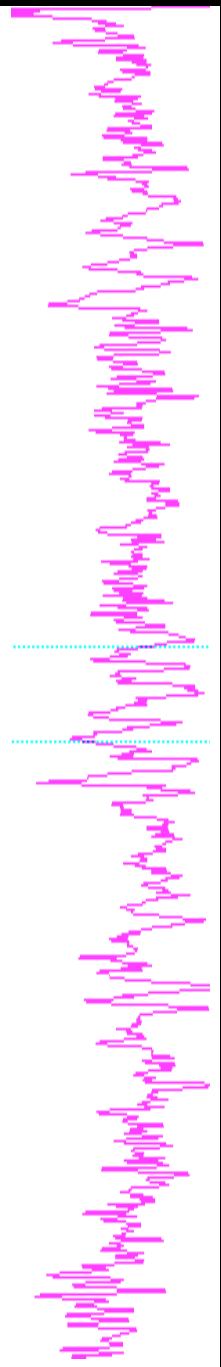
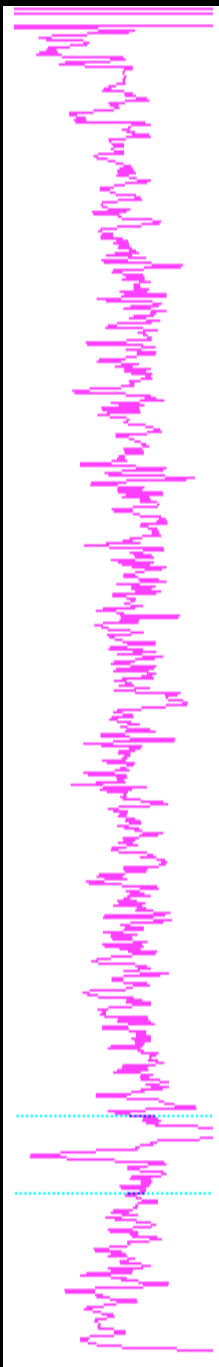
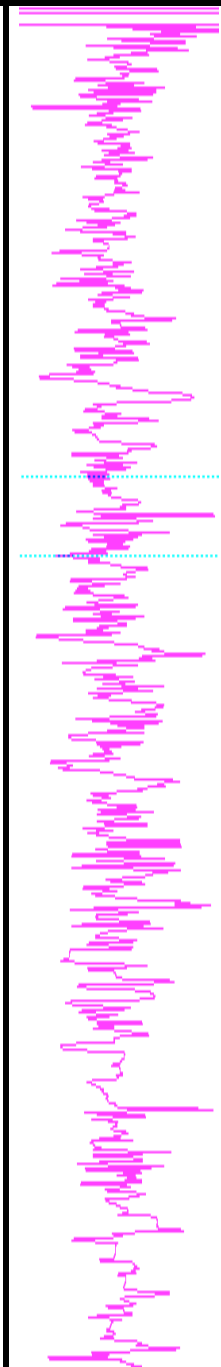
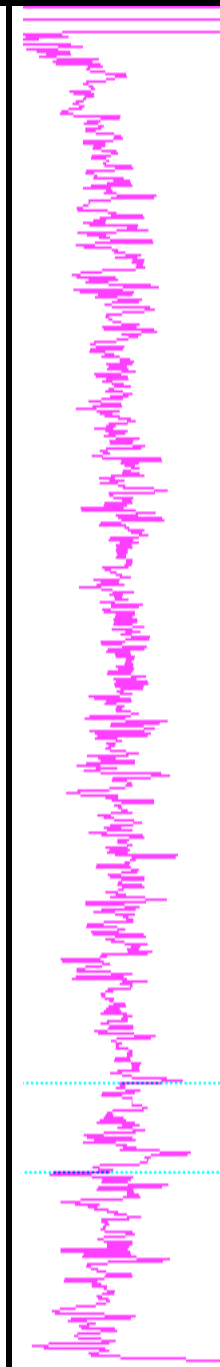
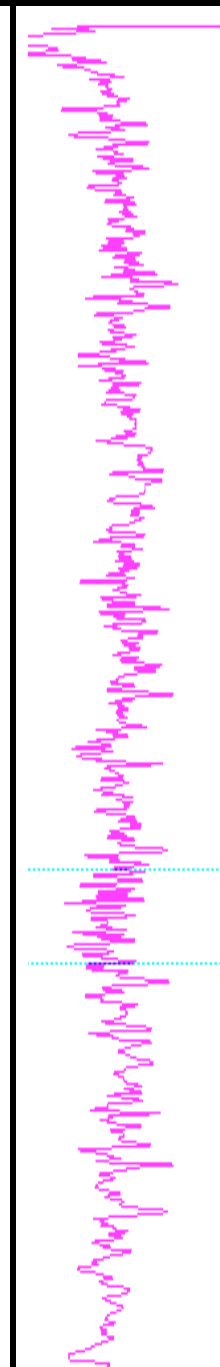
Tube Defect Report

Row-Column		2-10	2-11	2-12	2-13	2-14
Start : North	1

2					
	3					
Unit: Meter	4					
	5					
	6					
	7					
	8					
	9					
End: South	10					
	11					
	12.2

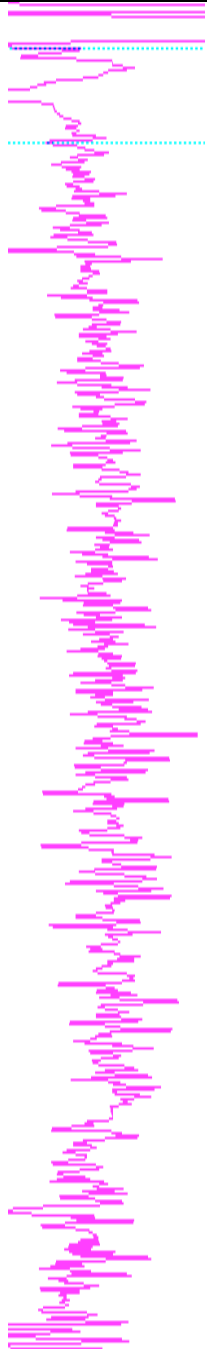
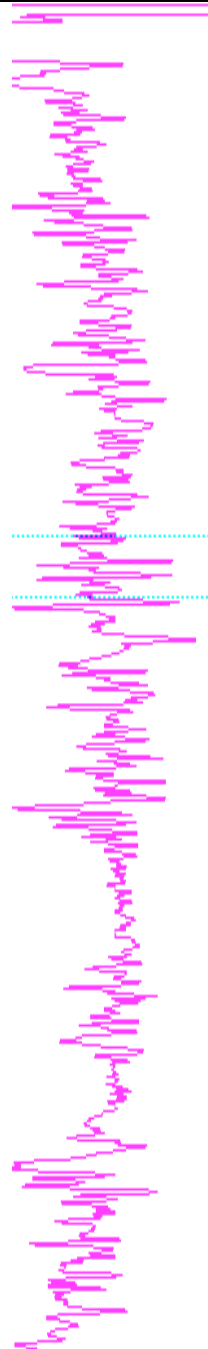
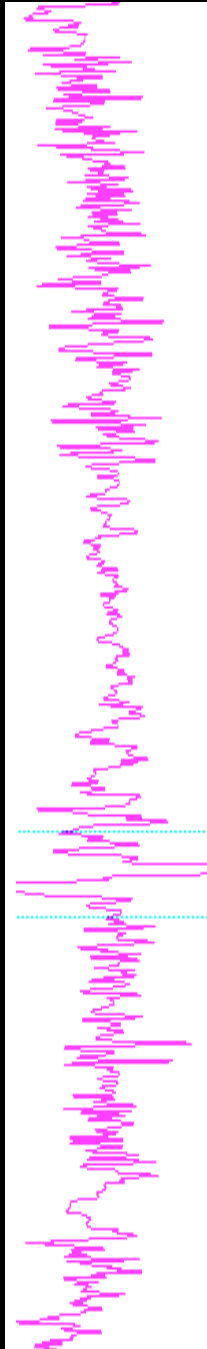
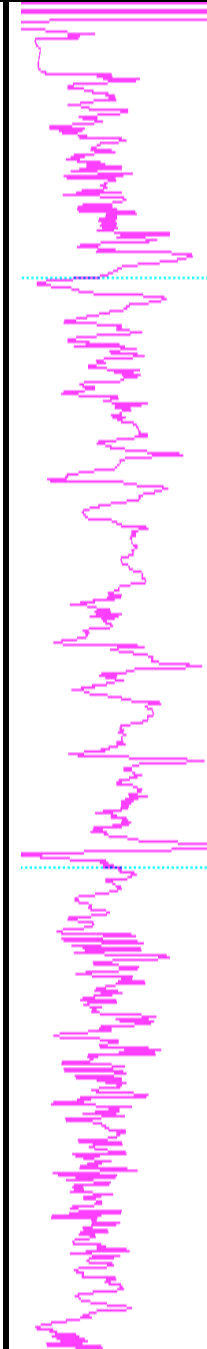
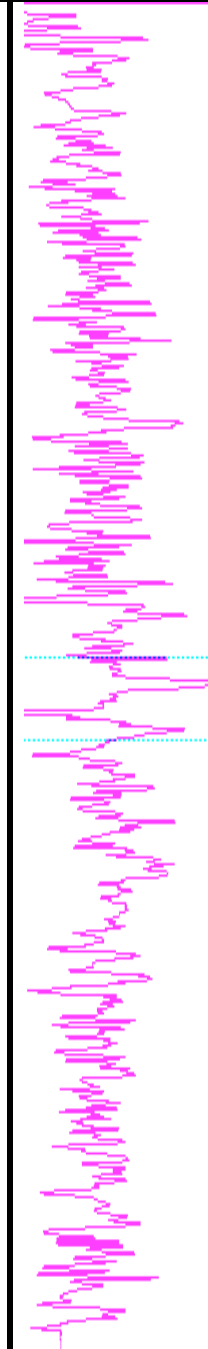
Tube Defect Report

Row-Column		2-25	2-26	2-27	2-28	2-29
Start : North	1

2					
	3					
Unit: Meter	4					
	5					
	6					
	7					
	8					
	9					
End: South	10					
	11					
	12.2

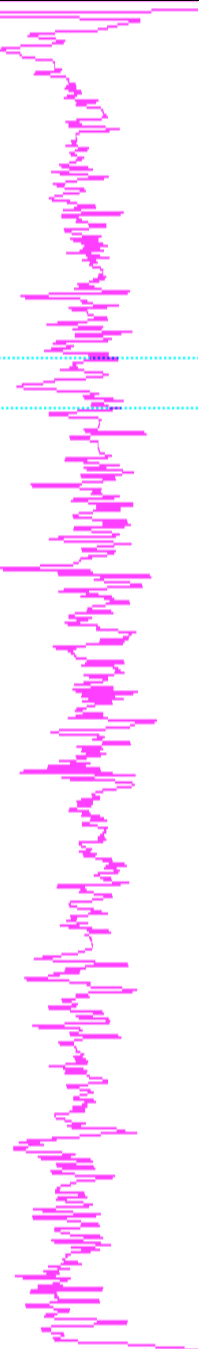
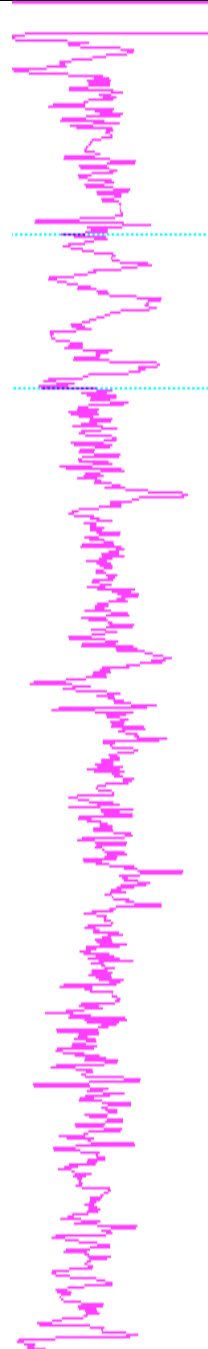
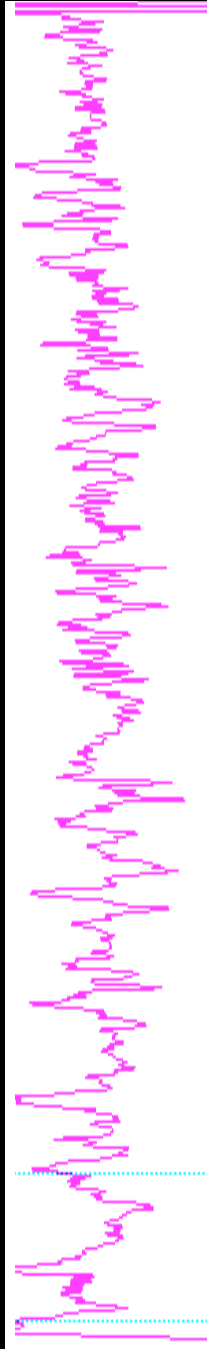
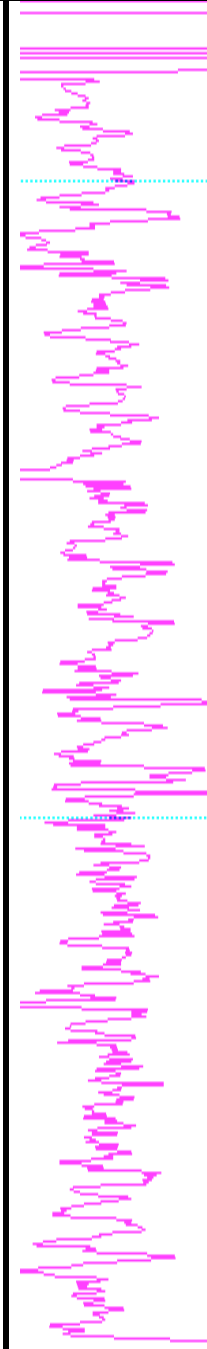
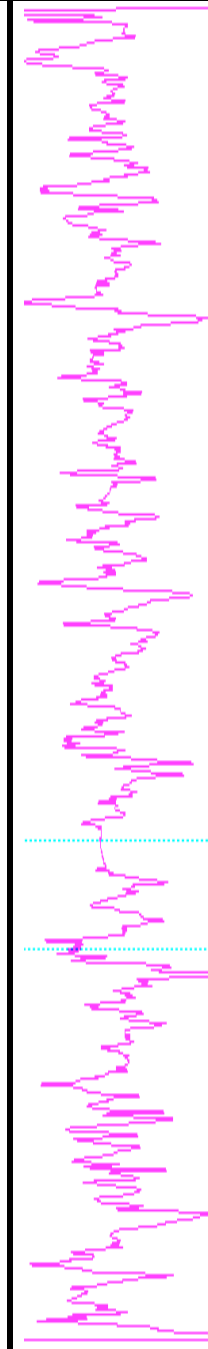
Tube Defect Report

Row-Column		2-35	2-36	2-37	2-38	2-39
Start : North	1

2					
	3					
Unit: Meter	4					
	5					
	6					
	7					
	8					
End: South	9					
	10					
	11					
	12.2

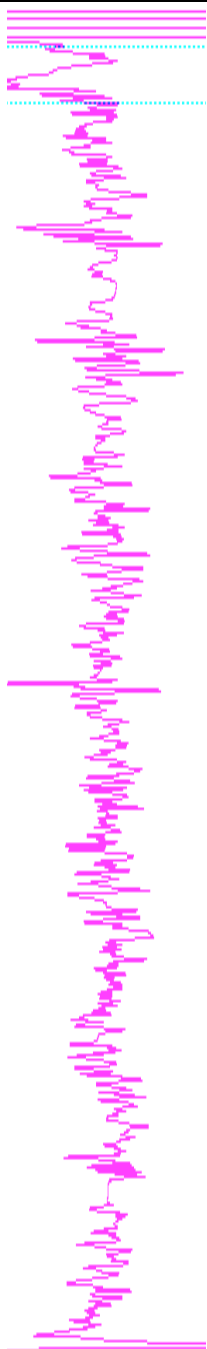
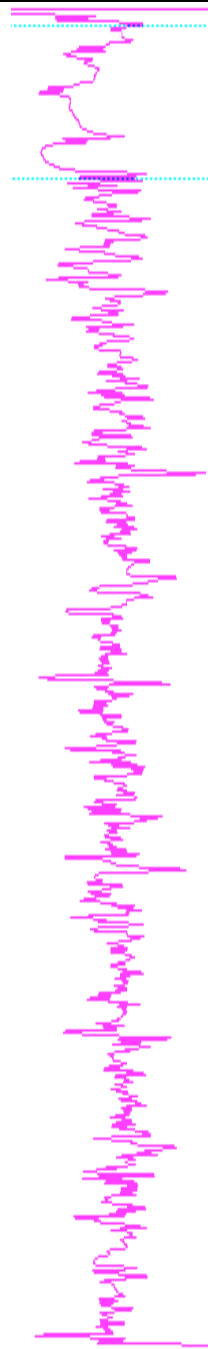
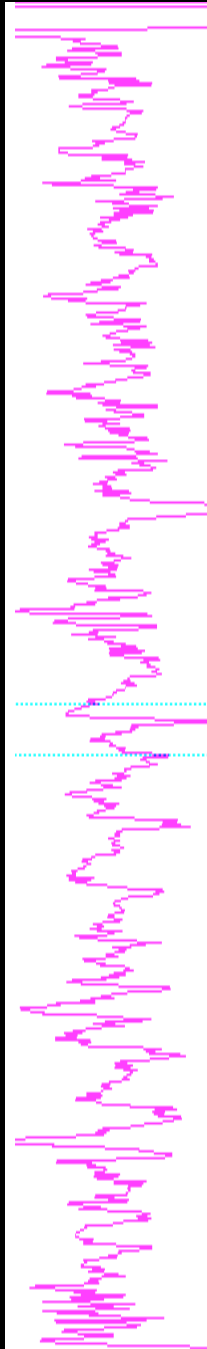
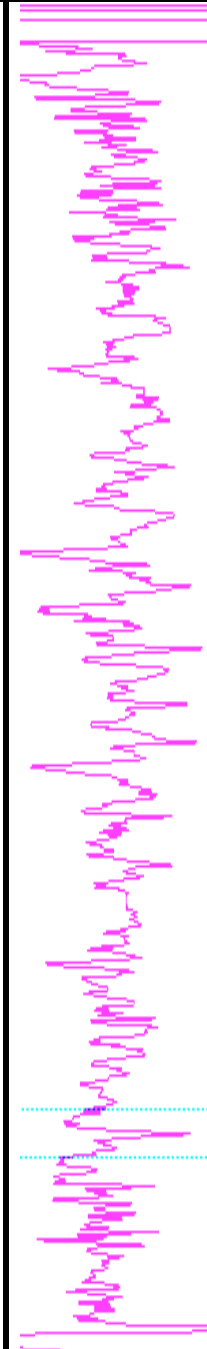
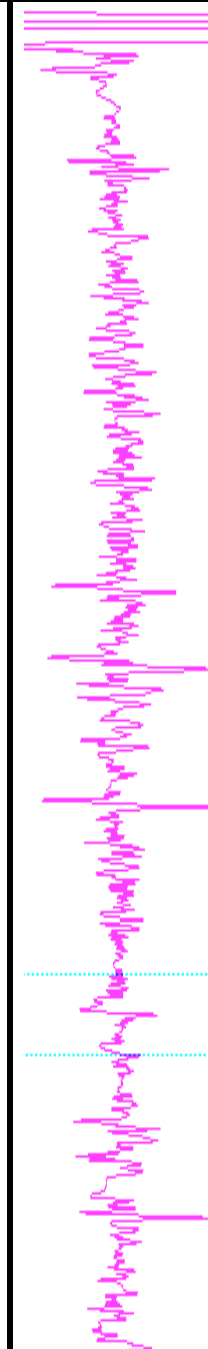
Tube Defect Report

Row-Column		2-50	2-51	2-52	2-53	2-54
Start : North	1

2					
	3					
Unit: Meter	4					
	5					
	6					
	7					
	8					
	9					
End: South	10					
	11					
	12.2

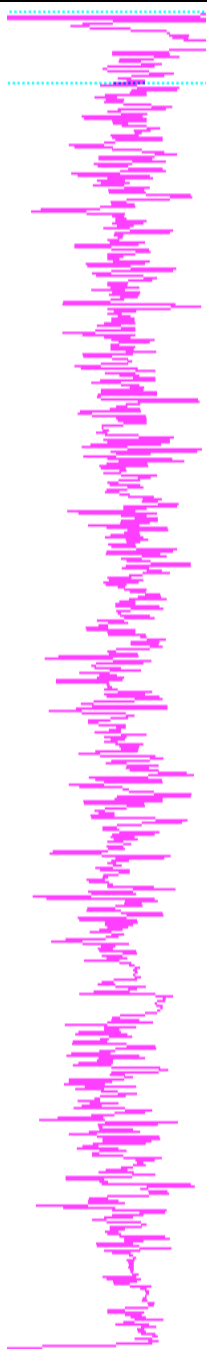
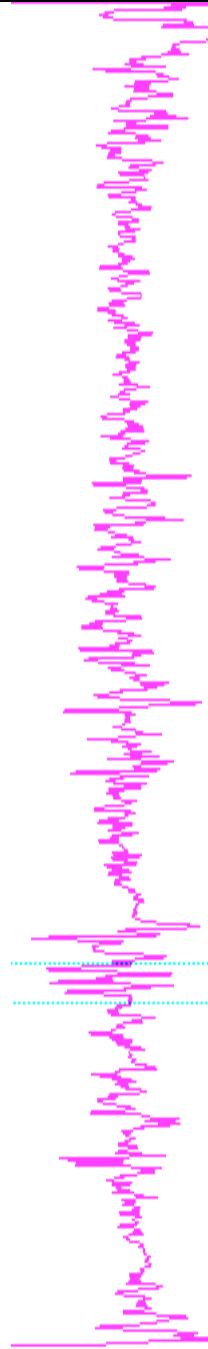
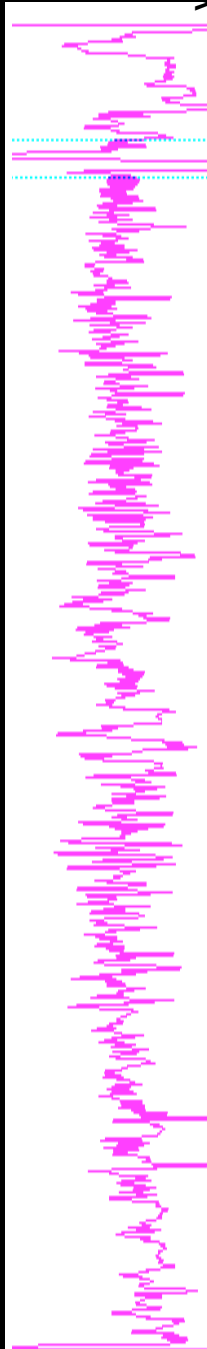
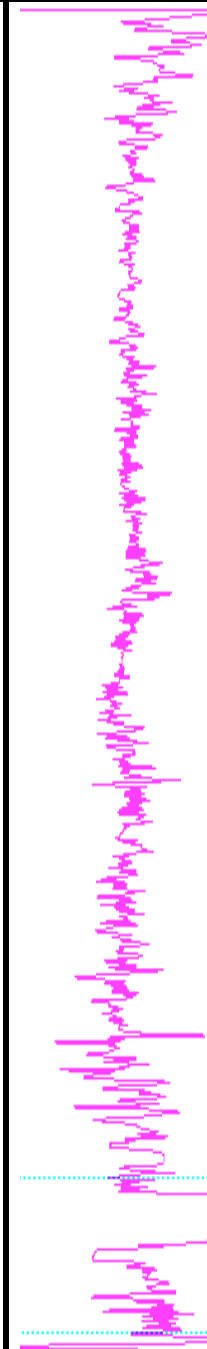
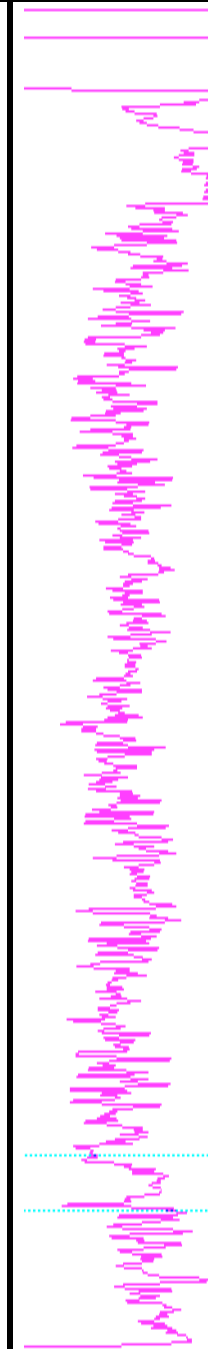
Tube Defect Report

Row-Column		3-9	3-10	3-11	3-12	3-13
Start : North	1

2					
	3					
Unit: Meter	4					
	5					
	6					
	7					
	8					
	9					
End: South	10					
	11					
	12.2

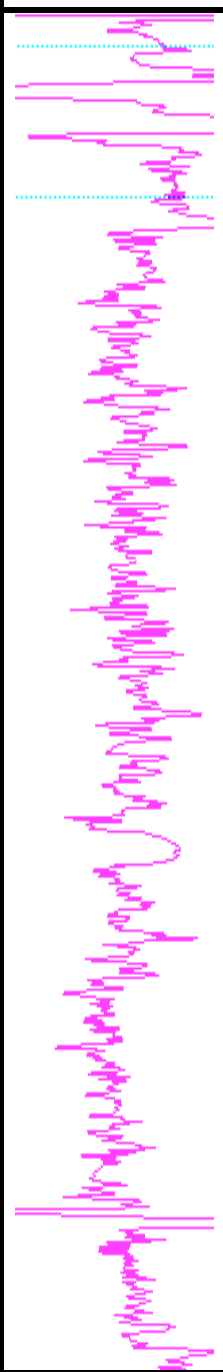
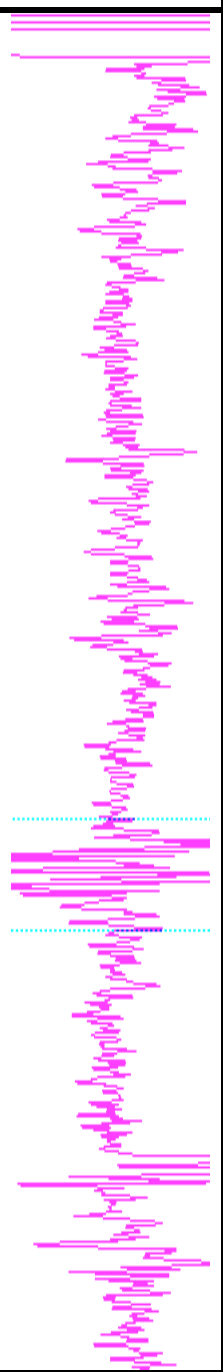
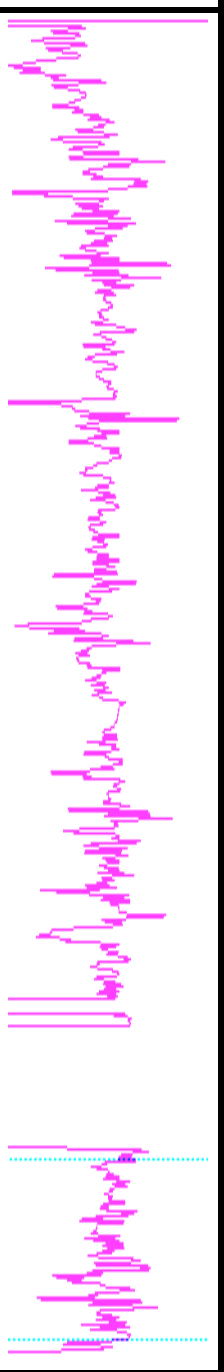
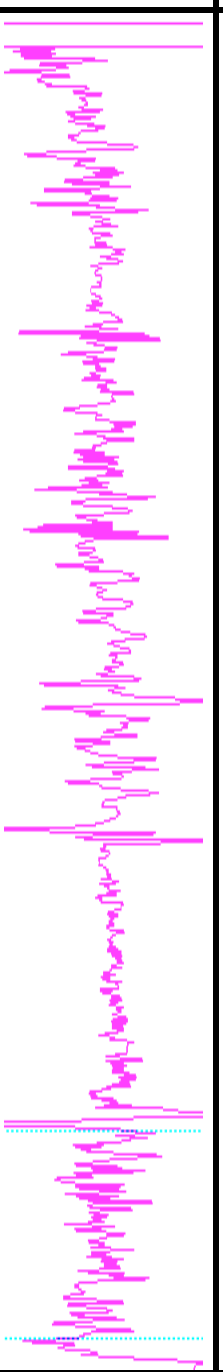
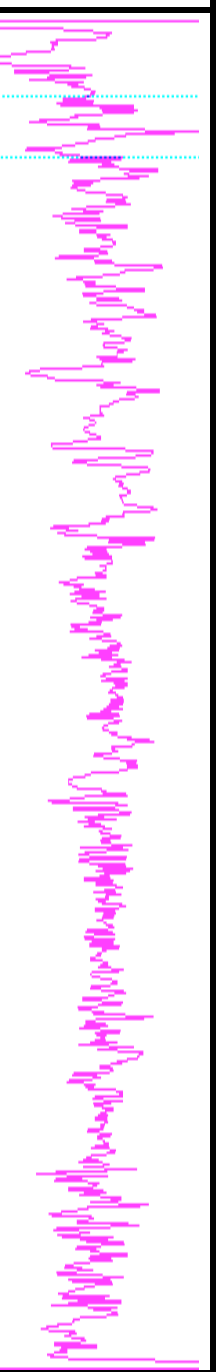
Tube Defect Report

Row-Column	3-19	3-20	3-21	3-22	3-23	
Start : North	1

2					
	3					
Unit: Meter	4					
	5					
	6					
	7					
	8					
	9					
End: South	10					
	11					
	12.2

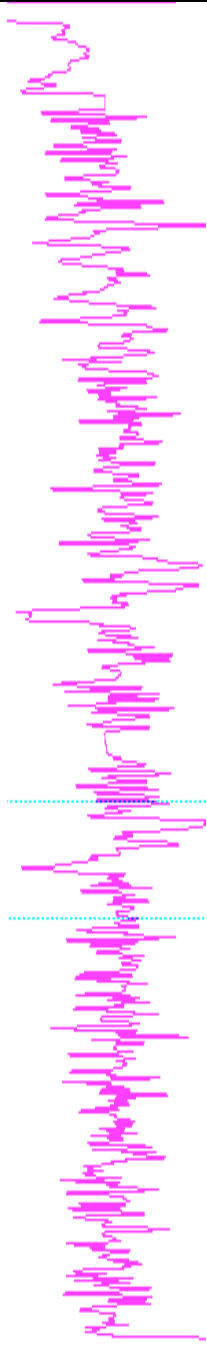
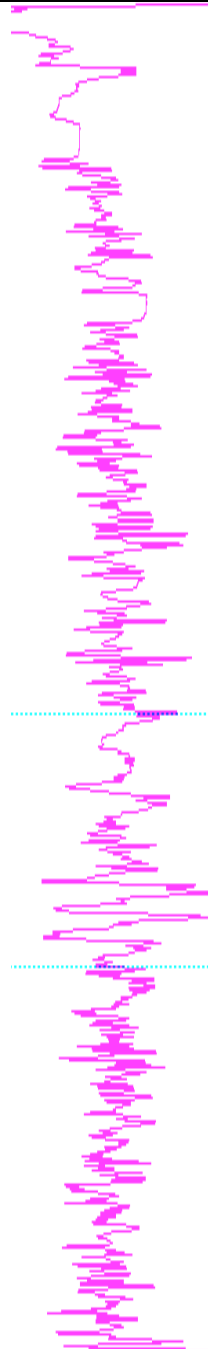
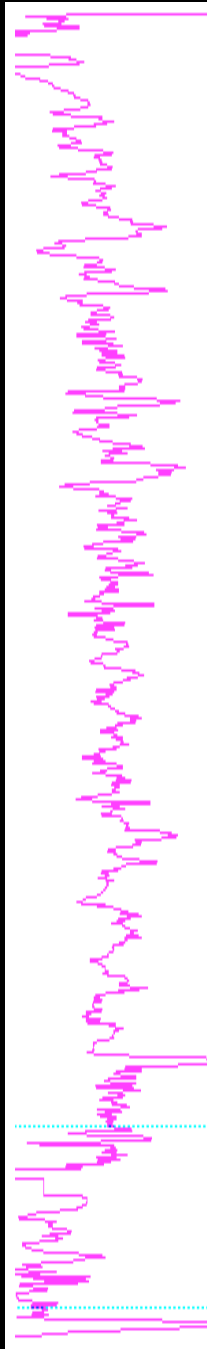
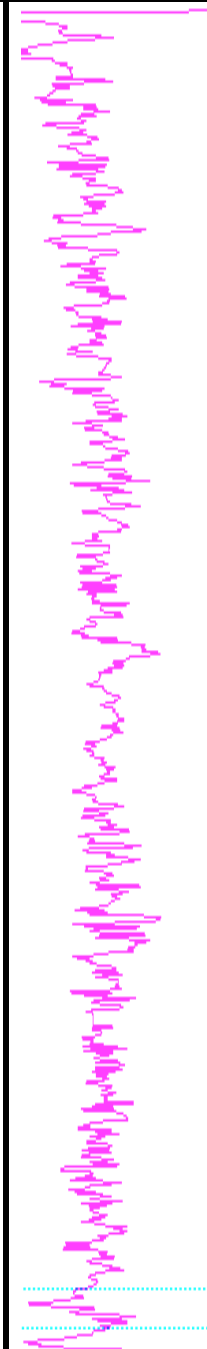
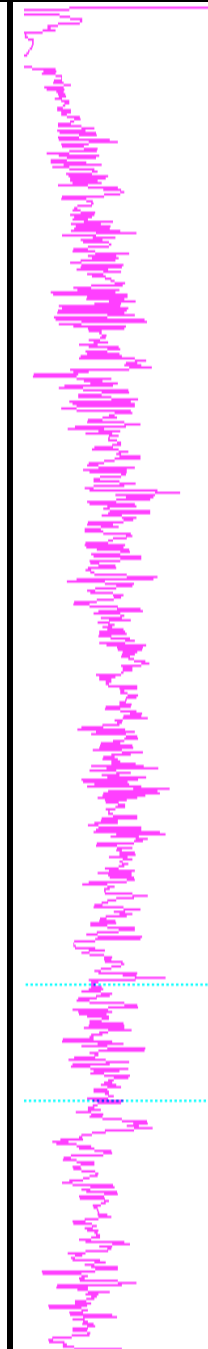
Tube Defect Report

Row-Column		3-29	3-30	3-31	3-32	3-33
Start : North	1

2					
	3					
Unit: Meter	4					
	5					
	6					
	7					
	8					
	9					
End: South	10					
	11					
	12.2

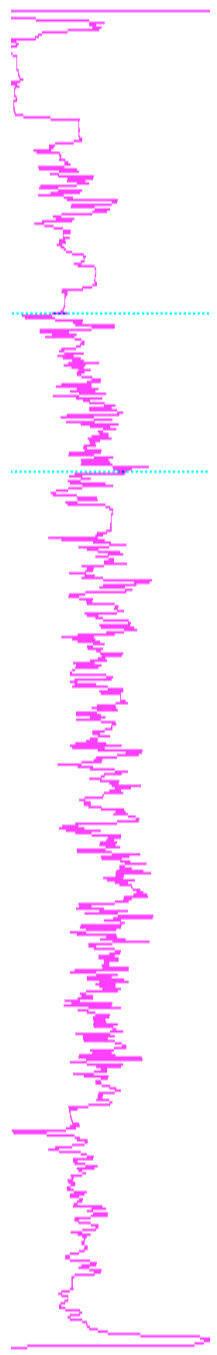
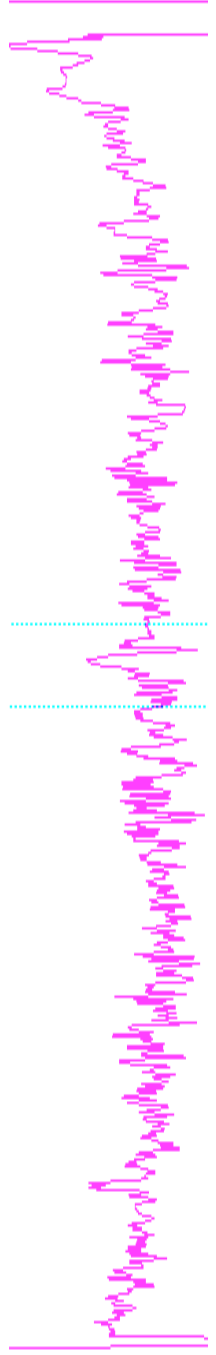
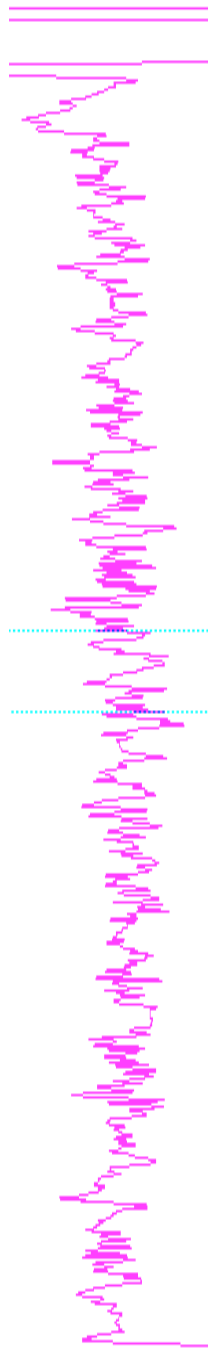
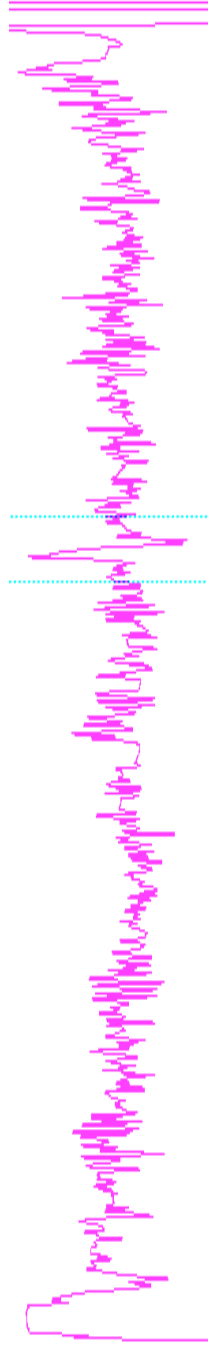
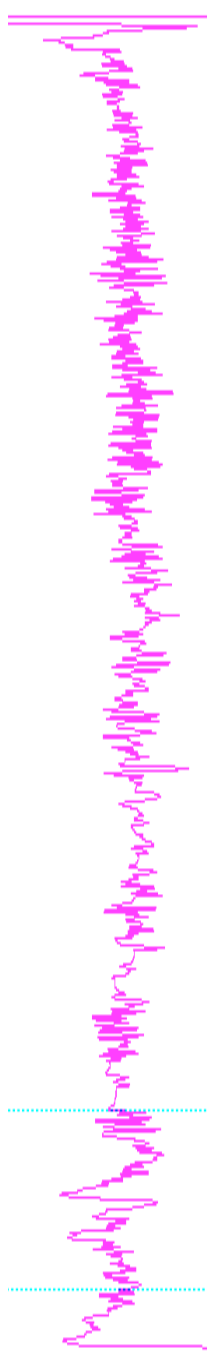
Tube Defect Report

Row-Column		3-34	3-35	3-36	3-37	3-38
Start : North	1

2					
	3					
Unit: Meter	4					
	5					
	6					
	7					
	8					
	9					
End: South	10					
	11					
	12.2

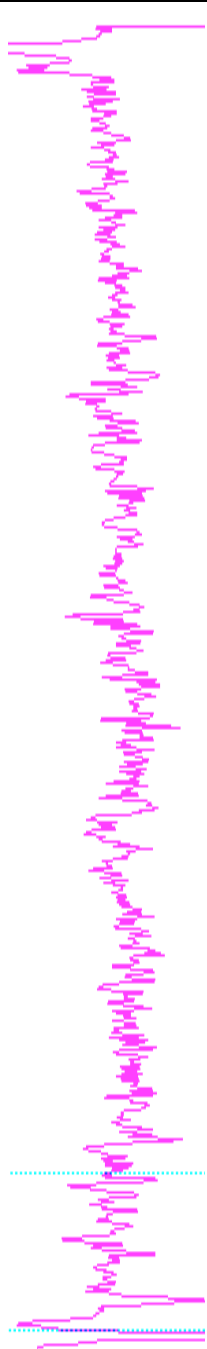
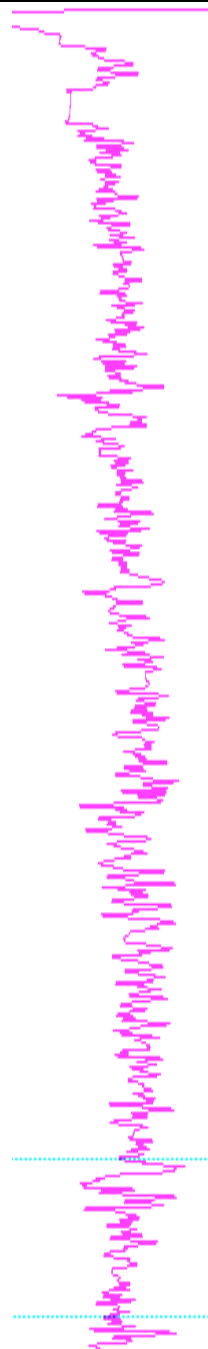
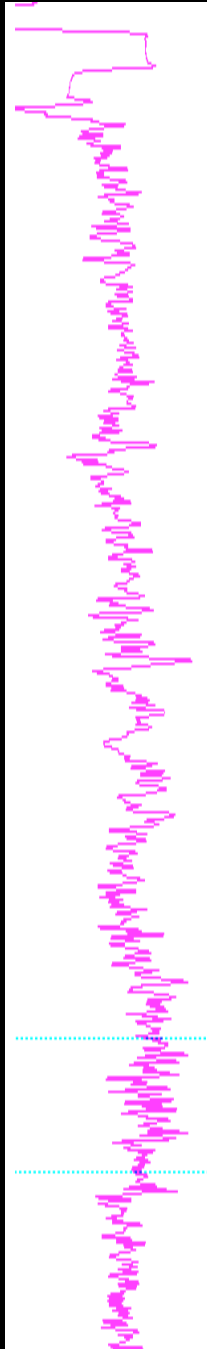
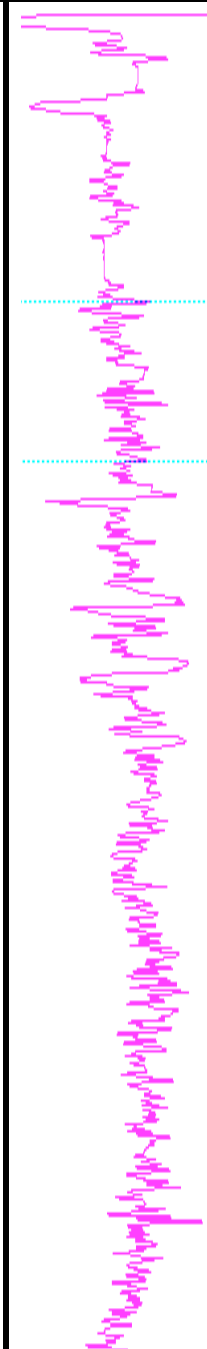
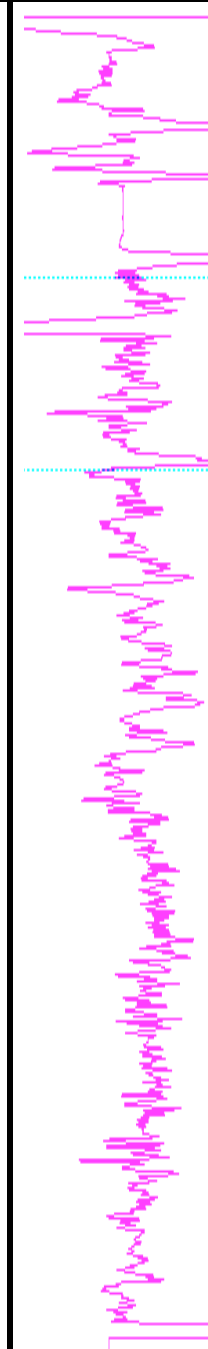
Tube Defect Report

Row-Column	3-44	3-45	3-46	3-47	3-48	
Start : North	1

2					
	3					
Unit: Meter	4					
	5					
	6					
	7					
	8					
	9					
End: South	10					
	11					
	12.2

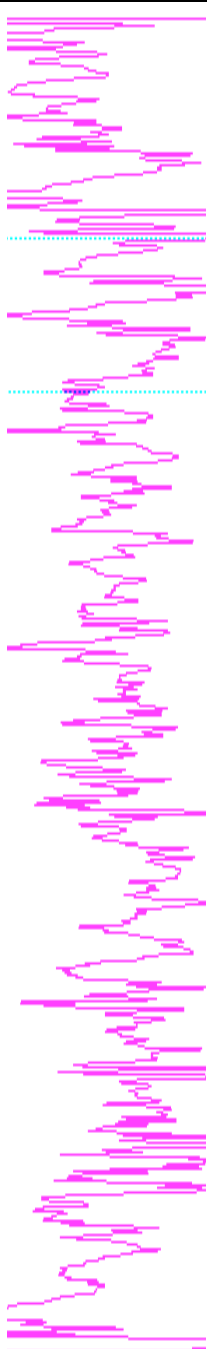
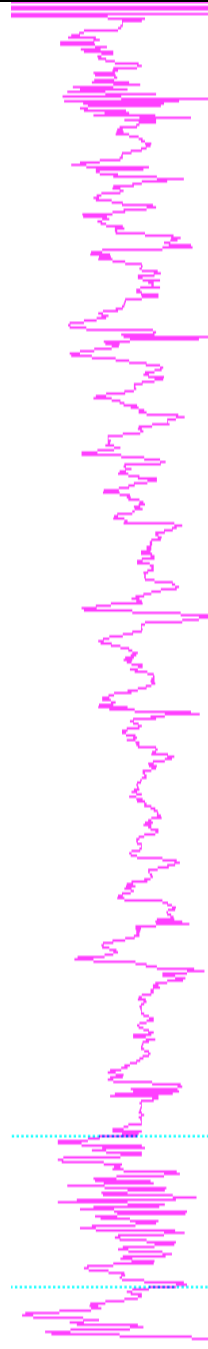
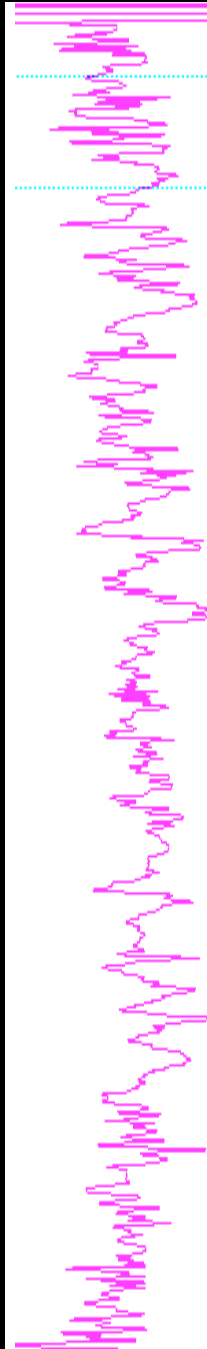
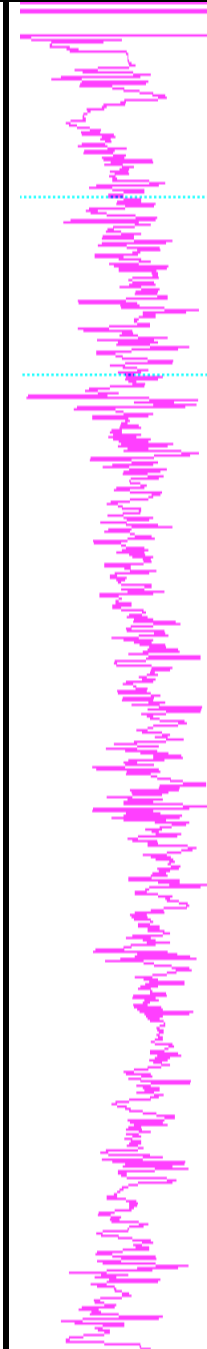
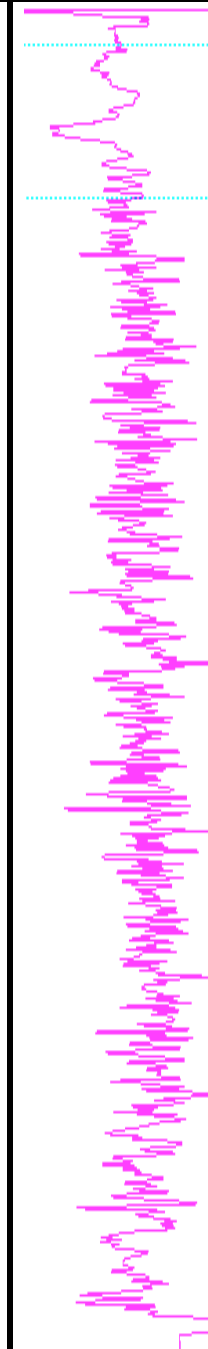
Tube Defect Report

Row-Column		4-18	4-19	4-20	4-21	4-22
Start : North	1

2					
	3					
Unit: Meter	4					
	5					
	6					
	7					
	8					
	9					
End: South	10					
	11					
	12.2
