گزارش بازرسی تیوب های کولرهای هوایی به روش

میدان دور جریان گردابی (RFT)

E-2109 / Section 2 / Cell 6 بازرسی تیوب های کولر هوایی

شرکت بازرسی فنی و کنترل خوردگی تکین کو

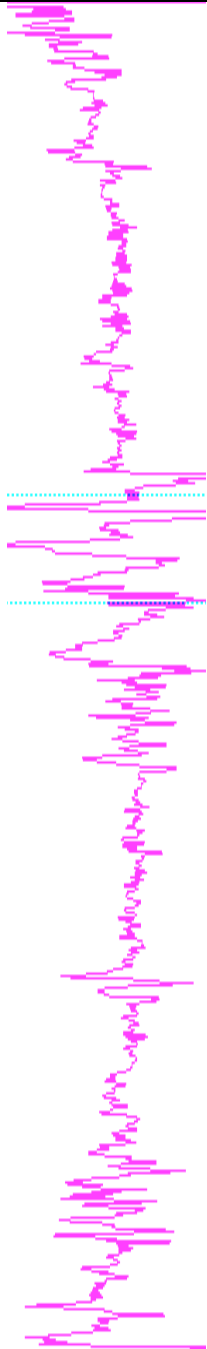
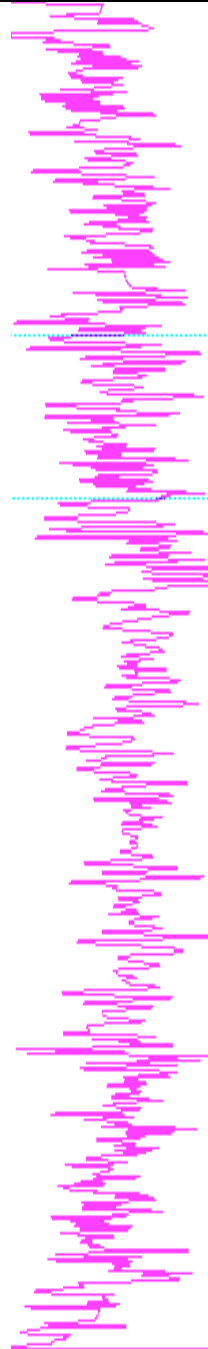
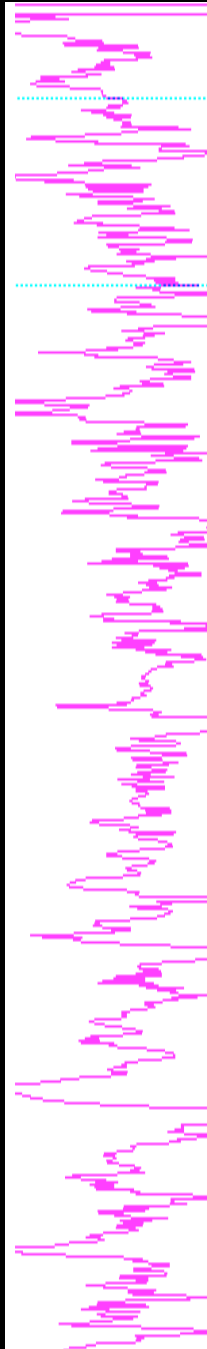
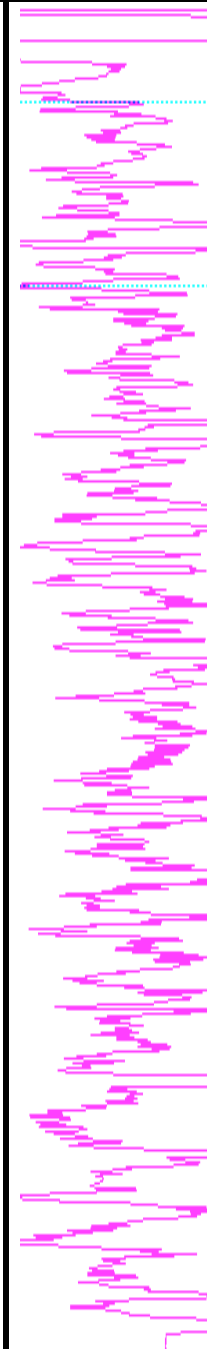
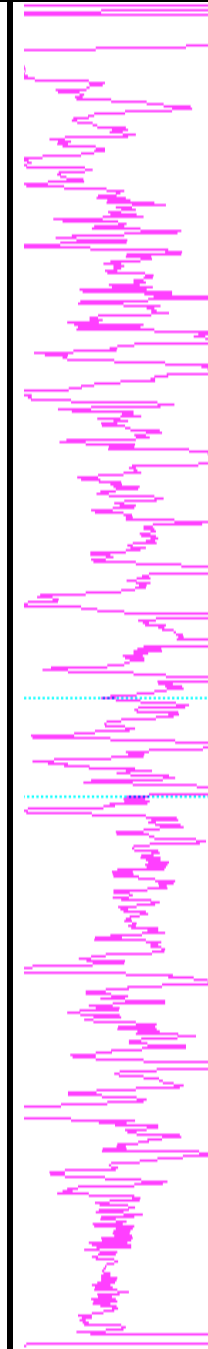
Row-Column		4-28	4-29	4-30	4-31	4-32
Start : North	1

2					
	3					
Unit: Meter	4					
	5					
	6					
	7					
	8					
End: South	9					
	10					
	11					
	12.2

بخش هشتم Tube Defect Report می باشد که در این گزارش موقعیت نسبی خوردگی متناسب با طول لوله نمایش داده میشود. این گزارش برای لوله هایی که دارای خوردگی (کلاس یک تا چهار) هستند موقعیت سیگنال خوردگی را بر روی گزارش استریپ چارت با خطوط آبی رنگ مشخص می نماید. همچنین سیگنال مربوطه به رنگ صورتی نیز نمایش داده می شوند.

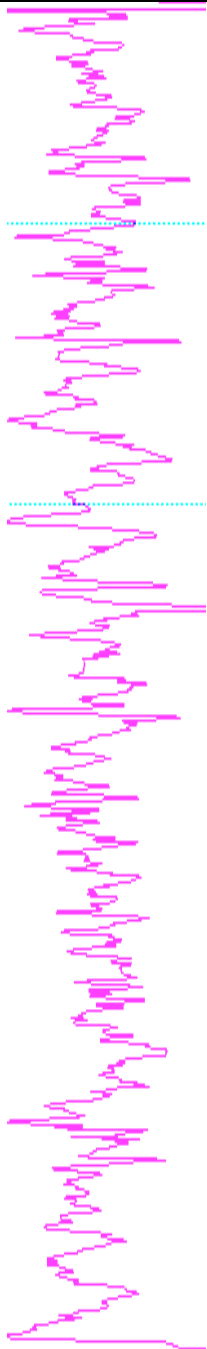
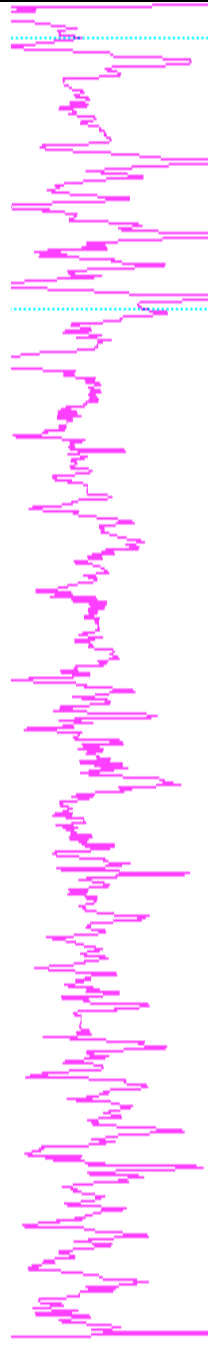
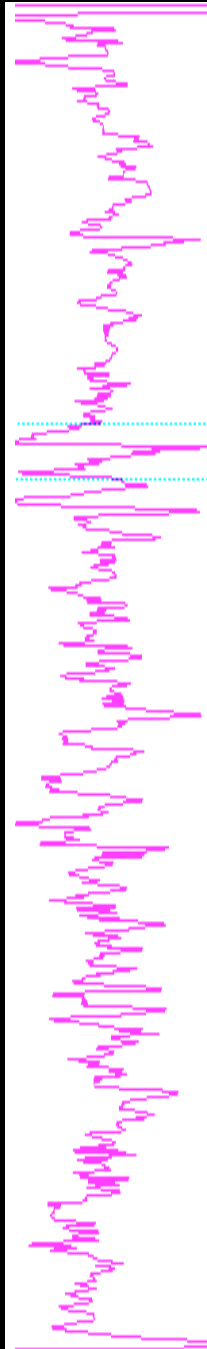
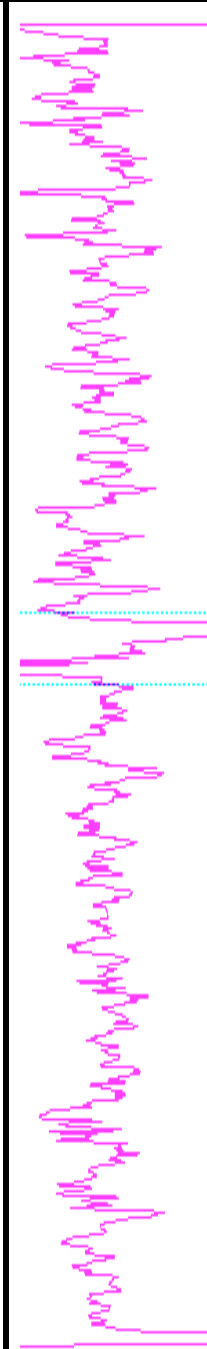
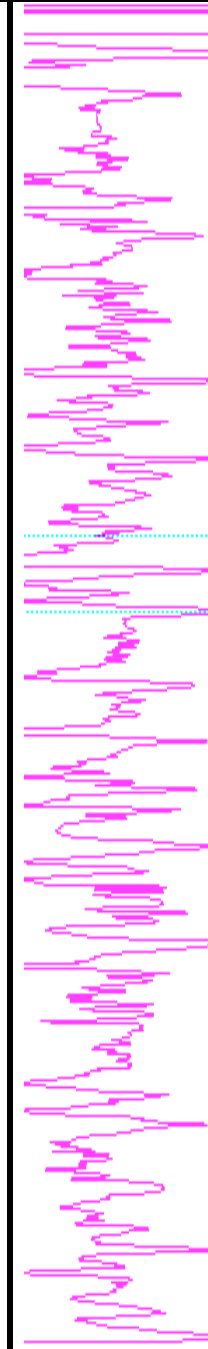
Tube Defect Report

Row-Column		4-38	4-39	4-40	4-41	4-42
Start : North	1

2					
	3					
Unit: Meter	4					
	5					
	6					
	7					
	8					
	9					
End: South	10					
	11					
	12.2

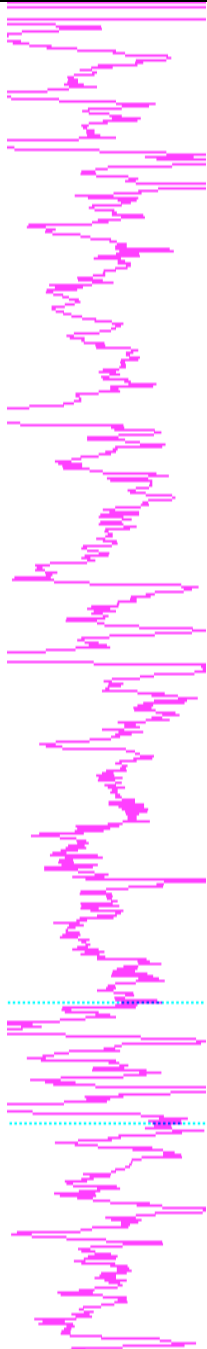
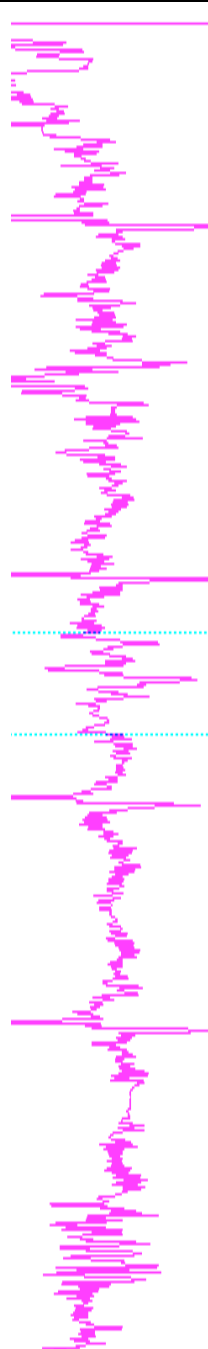
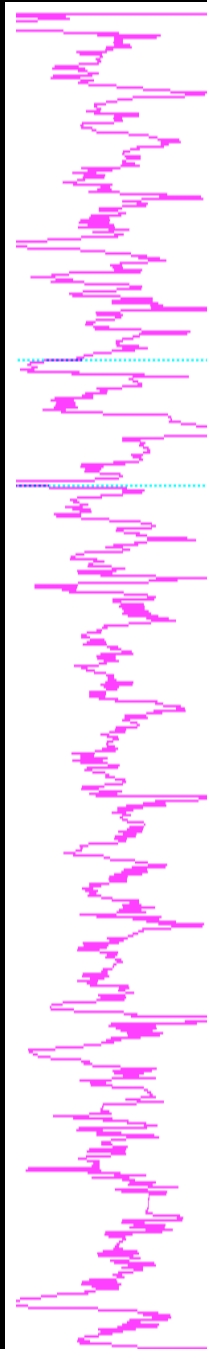
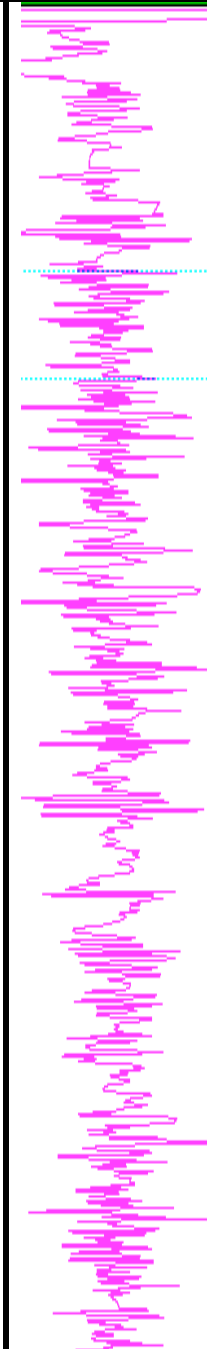
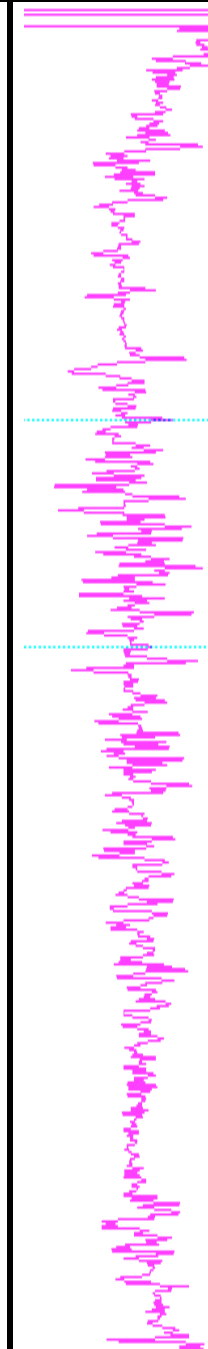
Tube Defect Report

Row-Column		4-53	4-54	4-55	4-56	5-1
Start : North	1

2					
	3					
Unit: Meter	4					
	5					
	6					
	7					
	8					
End: South	9					
	10					
	11					
	12.2

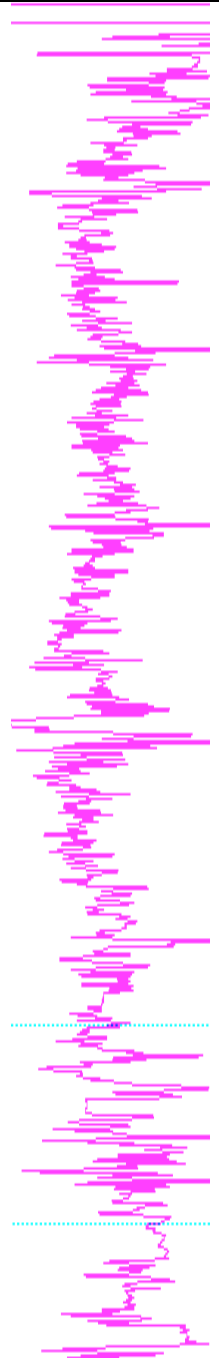
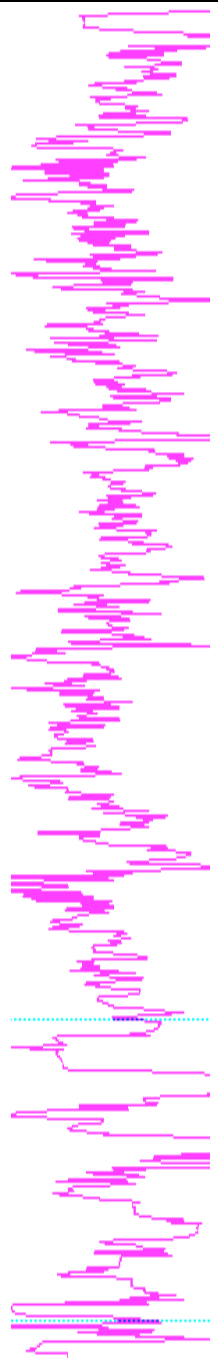
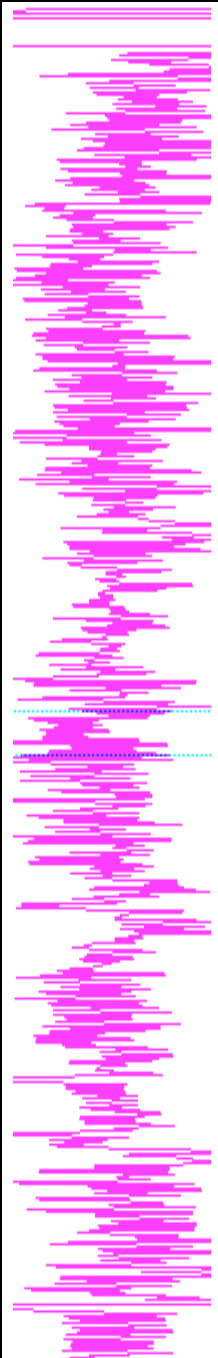
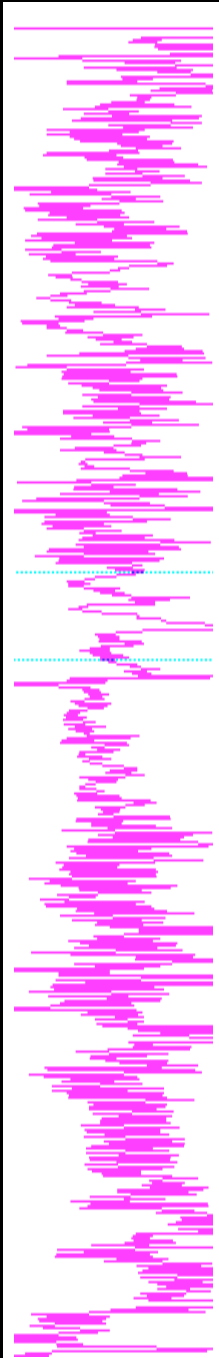
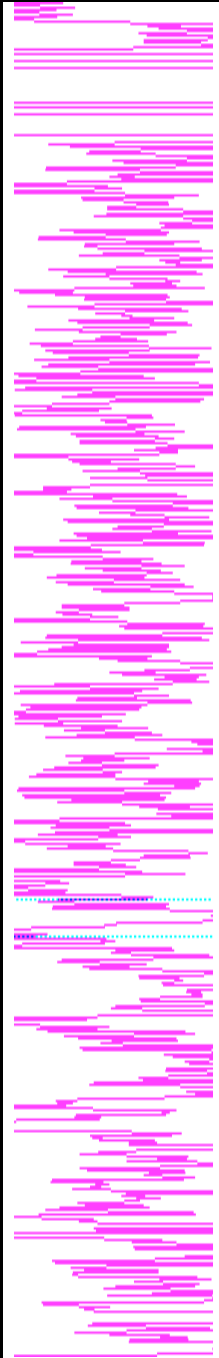
Tube Defect Report

Row-Column		5-17	5-18	5-19	5-20	5-21
Start : North	1

2					
	3					
Unit: Meter	4					
	5					
	6					
	7					
	8					
	9					
End: South	10					
	11					
	12.2

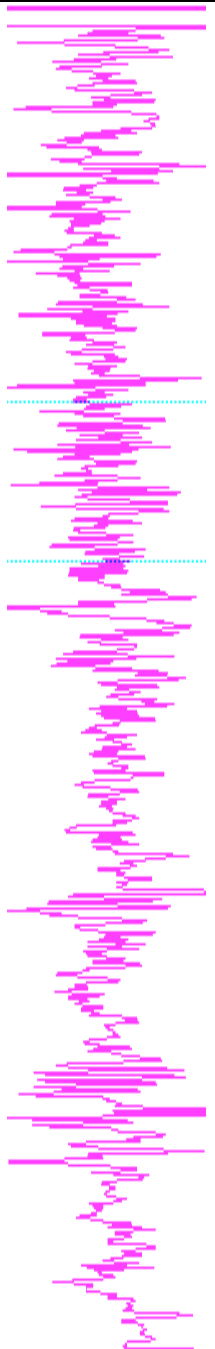
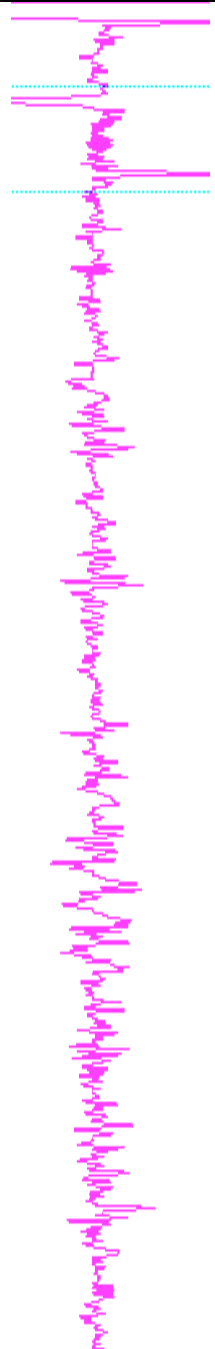
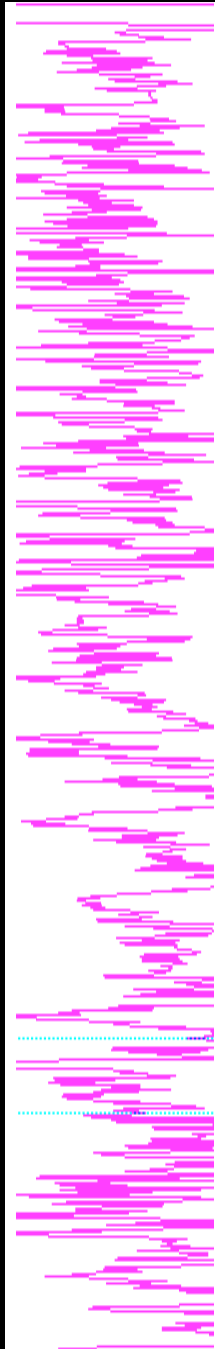
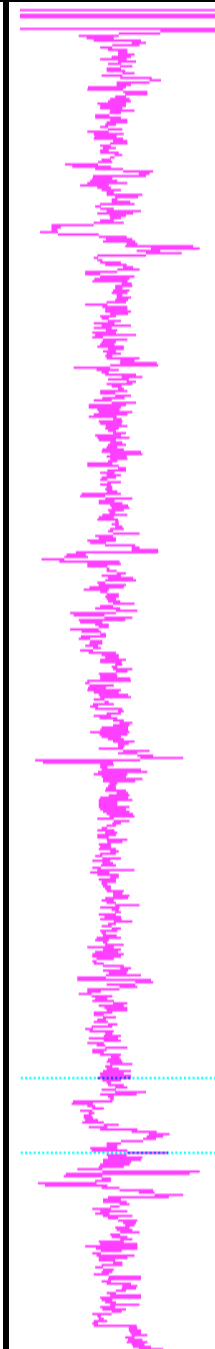
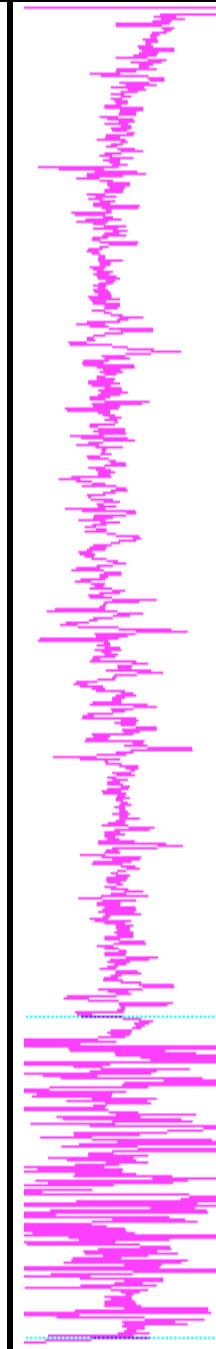
Tube Defect Report

Row-Column		5-52	5-53	5-54	5-55	5-56
Start : North	1

2					
	3					
Unit: Meter	4					
	5					
	6					
	7					
	8					
End: South	9					
	10					
	11					
	12.2
